# VEHICLE INSPECTION REPORT

**BN14WUY**

## Iveco Eurocargo 75E16

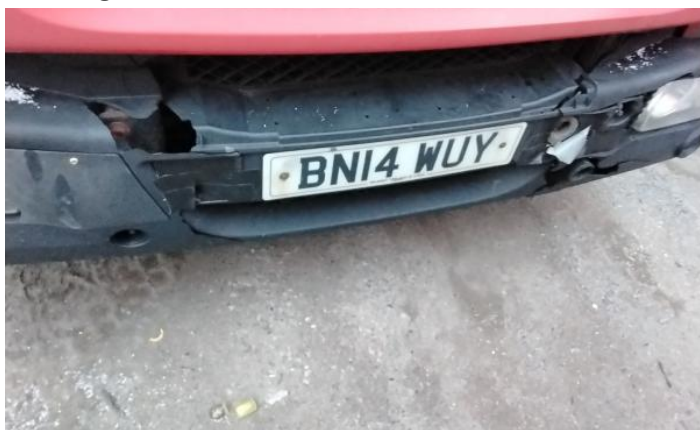
1: Bumper Front  
Cracked  
Over 25mm

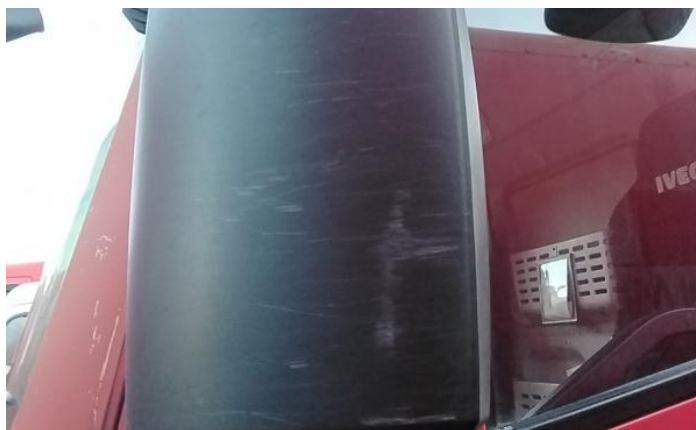
2: Door Mirror Assy nsf  
Scuffed (Unpainted)  
Over 100mm

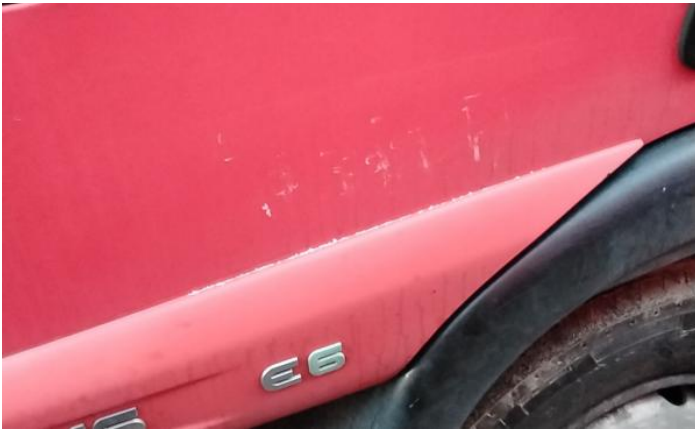
3: Door nsf  
 Scratched  
 Over 25mm Thru Paint

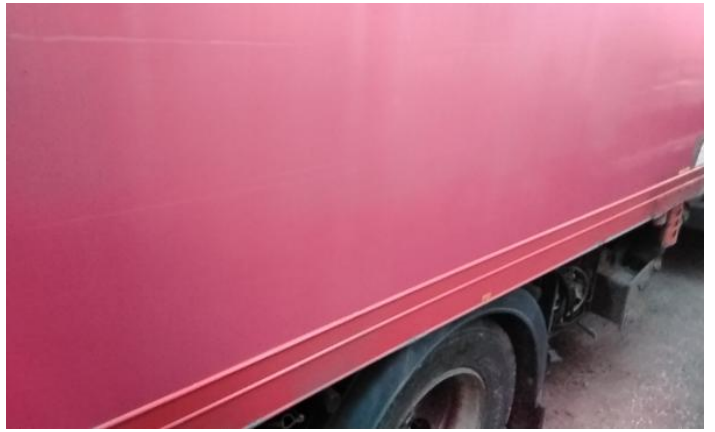
4: Qtr Panel nsr  
 Scratched  
 Over 25mm Thru Paint

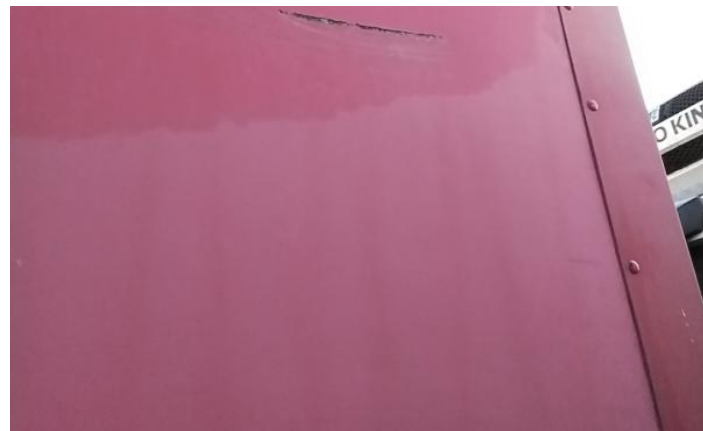
5: Qtr Panel nsr  
 Scratched  
 Over 25mm Thru Paint

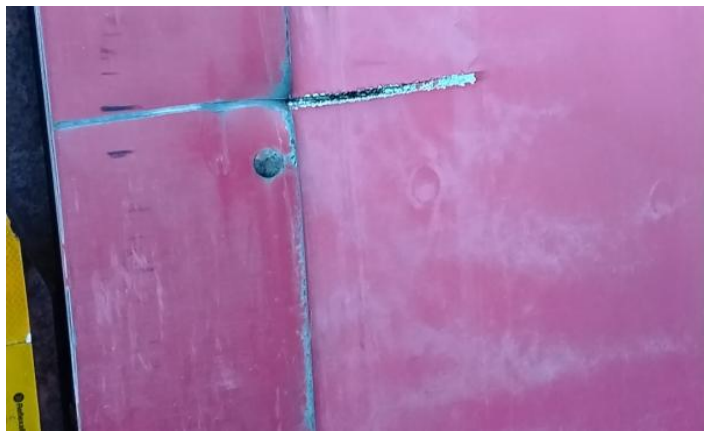
6: Qtr Panel osr  
 Cracked  
 Replace

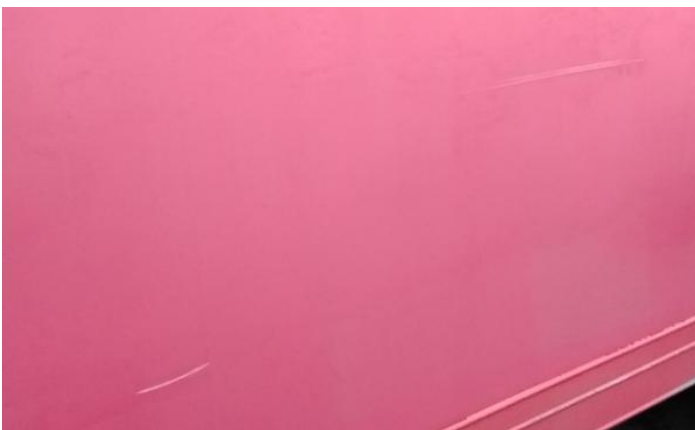
7: Qtr Panel osr  
 Scratched  
 Over 25mm Thru Paint

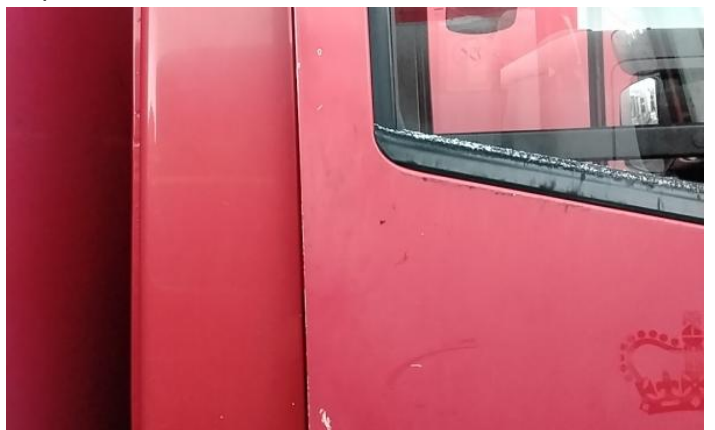
8: Door osf  
 Dented  
 With Paint Damage

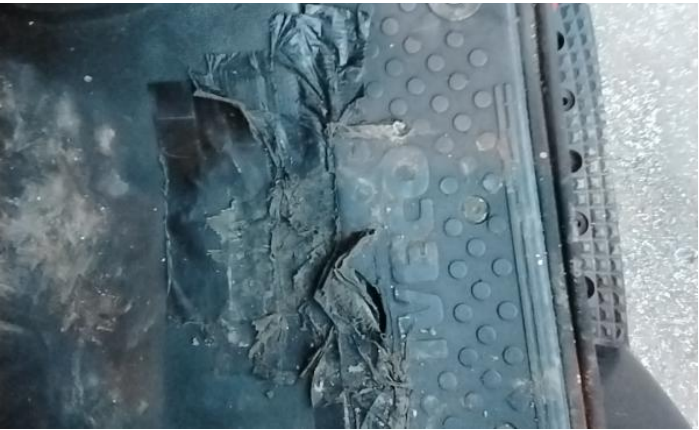
10: Carpets Front  
Holed  
Over 3mm

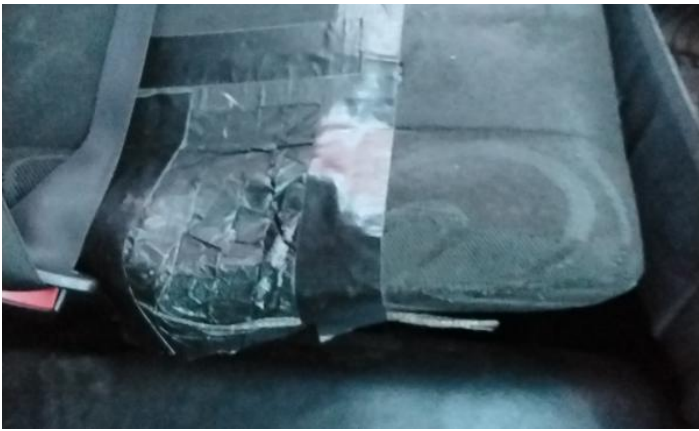
11: Seat Base Cover nsf  
Holed  
Over 3mm
