# VEHICLE INSPECTION REPORT

**SA21ZZF**

## Fiat Doblo Work Up 1.6 Multijet II 16V

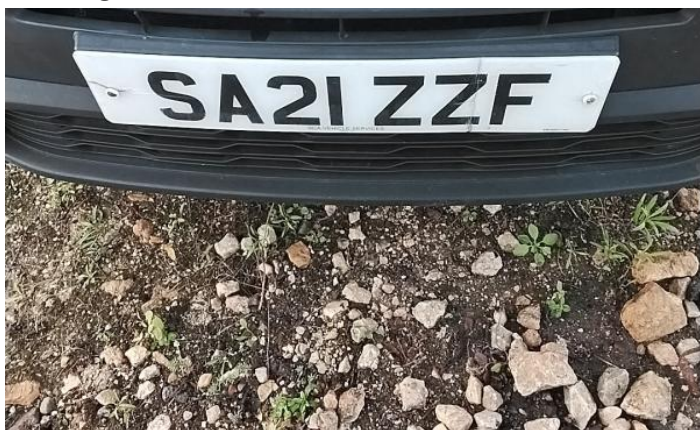
1: Number Plate Front  
Broken  
Replace

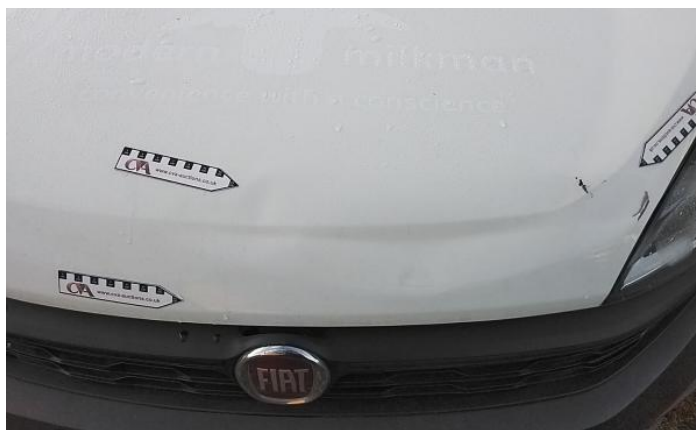
2: Bonnet  
Dented  
With Paint Damage

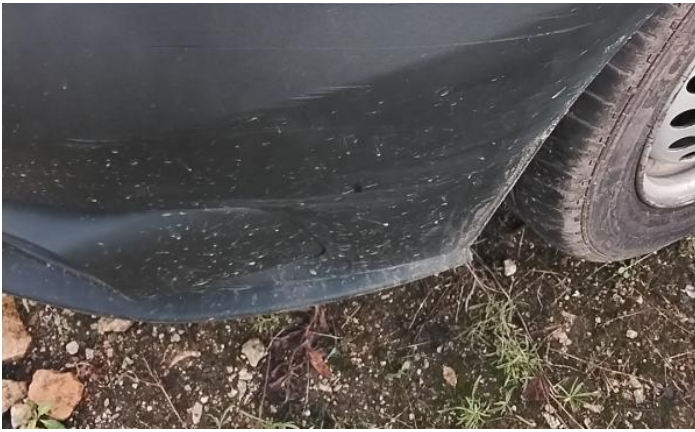
3: Bumper Front  
Scratched  
Over 100mm Thru Paint

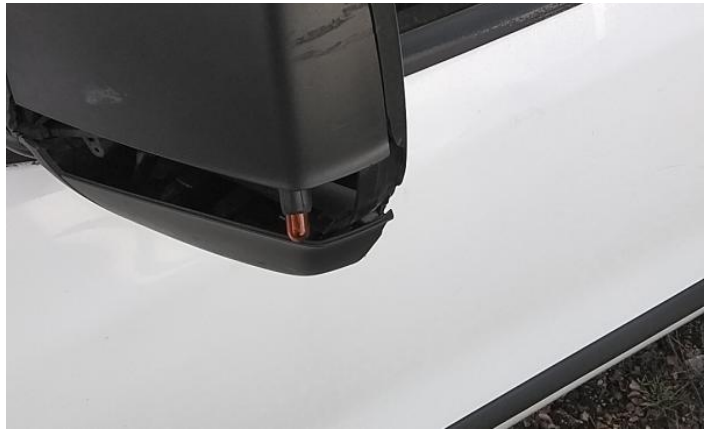
4: Door Mirror Assy nsf  
Broken  
Replace

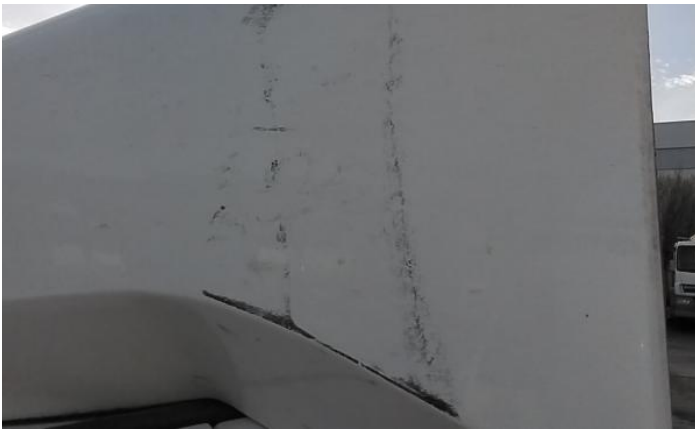
5: Qtr Panel Trim ns  
Scuffed  
Over 25mm

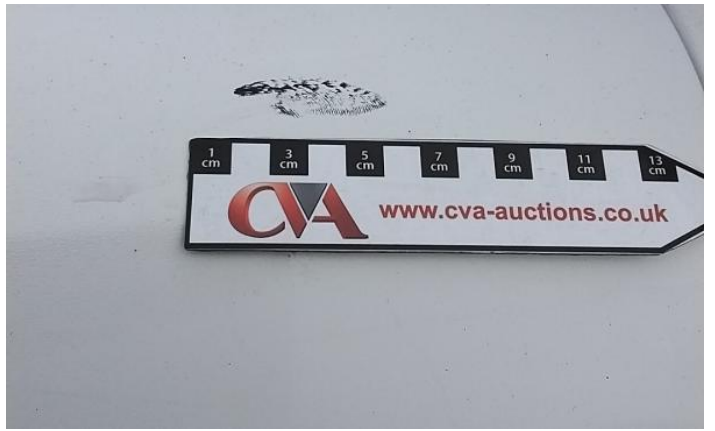
6: Door nsf  
Scratched  
Over 25mm Not Thru Paint

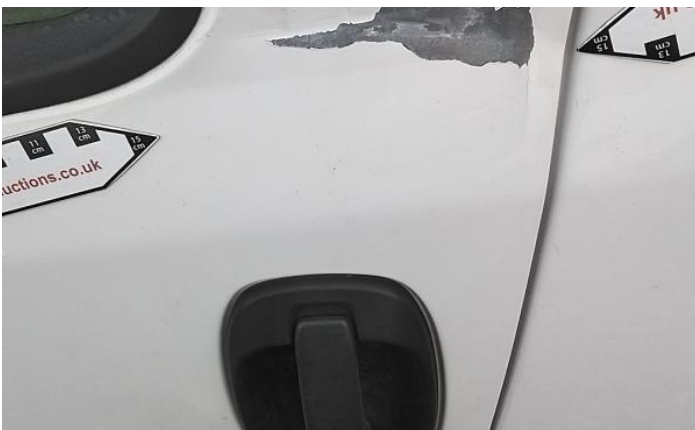
7: Door nsf  
Dented  
With Paint Damage

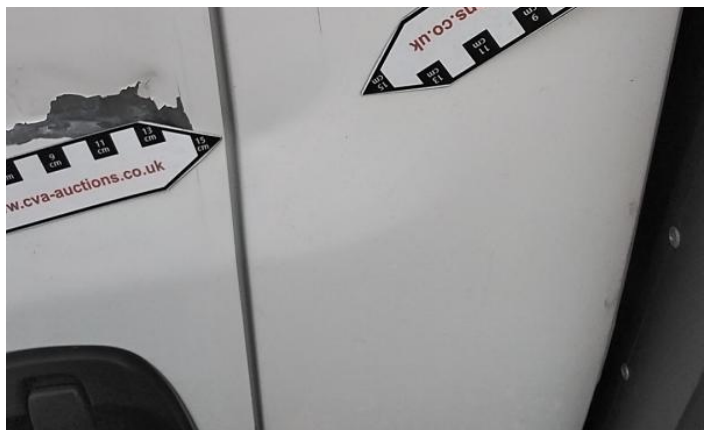
8: B Post ns  
Dented  
Over 30mm

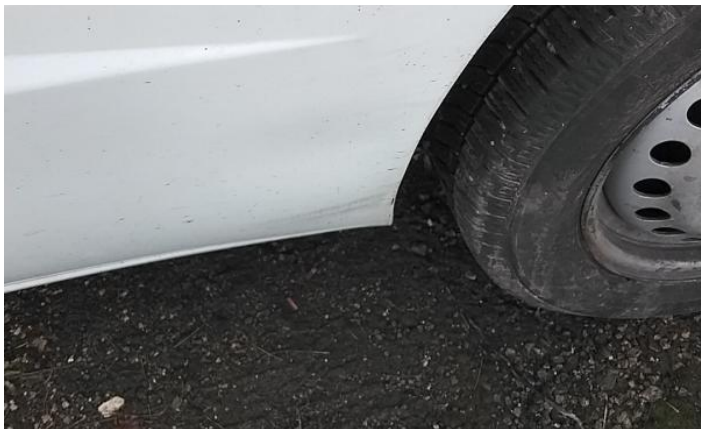
9: Qtr Panel nsr  
Dented  
Over 30mm

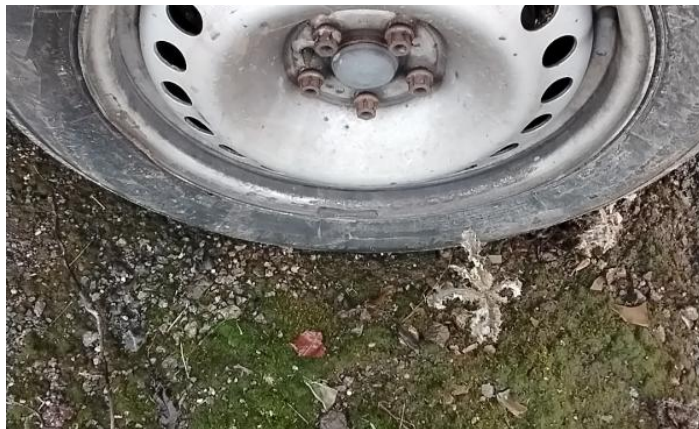
10: Wheel nsr  
Dented  
Over 30mm (Steel)

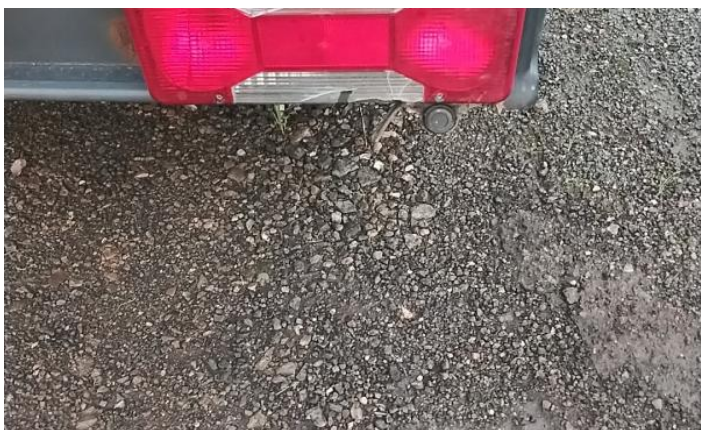
11: Lamp osr  
Broken  
Replace

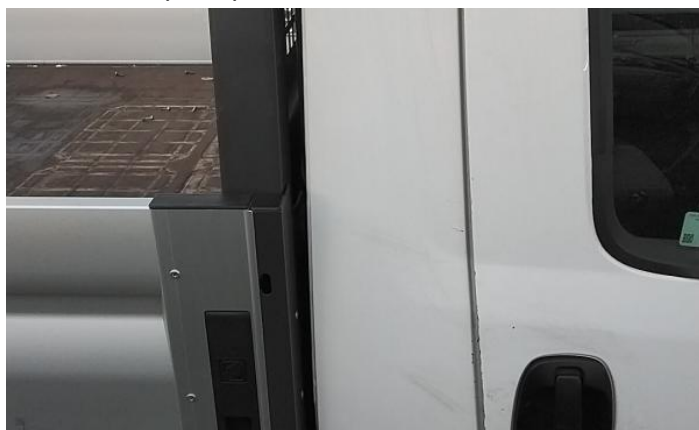
12: B Post os  
Scratched  
Over 25mm Thru Paint

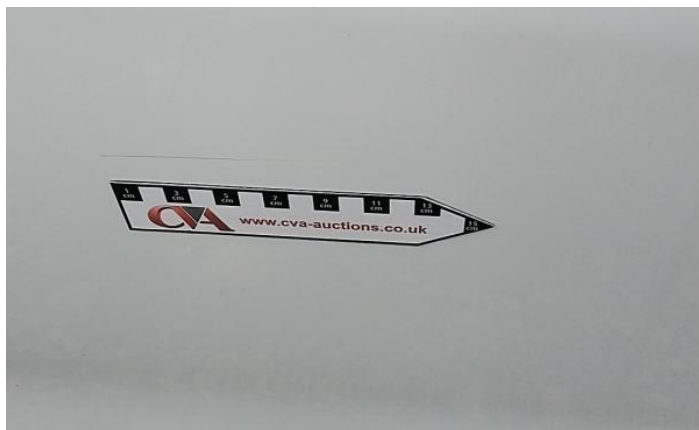
14: Door osf  
Scratched  
Over 25mm Thru Paint

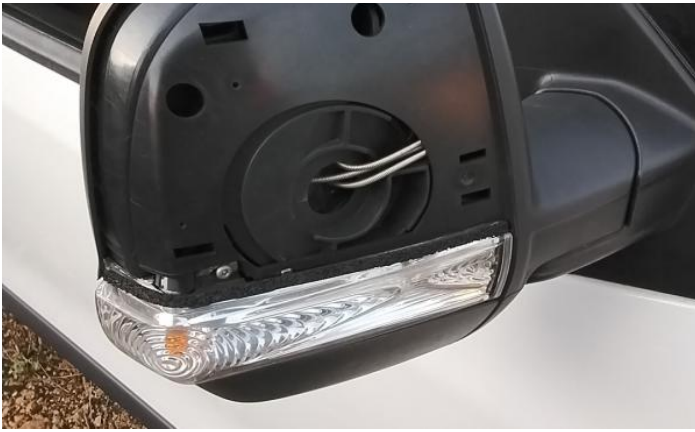
15: Door Mirror Assy osf  
Broken  
Replace

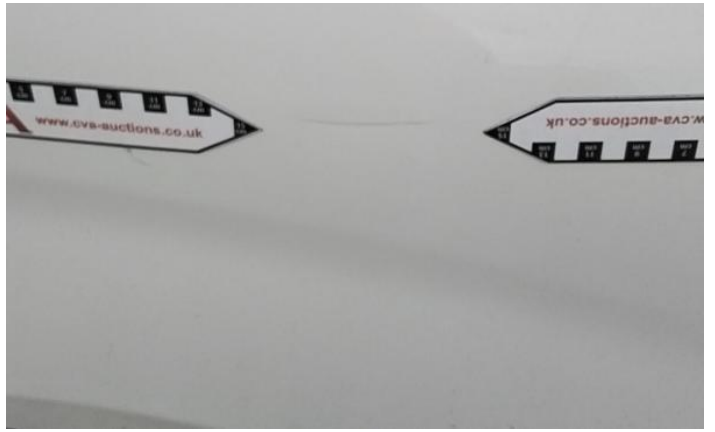
16: Wing osf  
Dented  
With Paint Damage

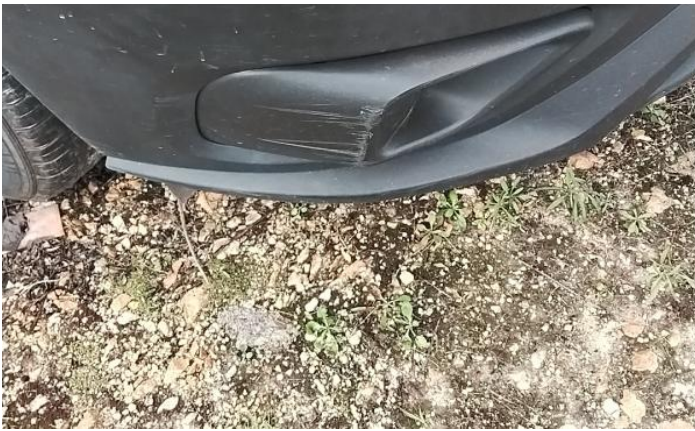
17: Bumper Front Moulding  
Scuffed (Unpainted)  
Over 100mm

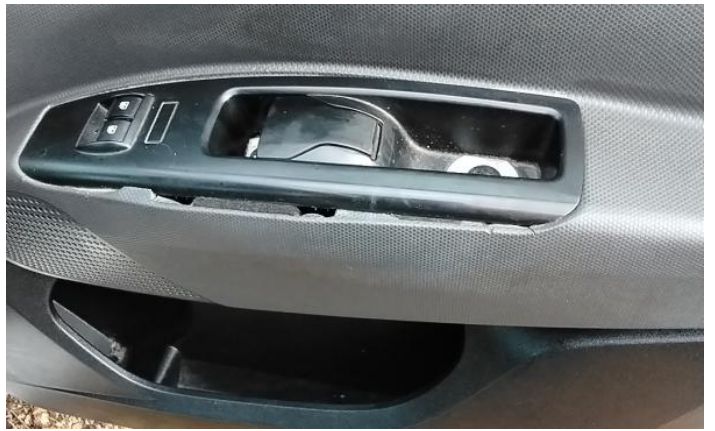
18: Door Pad osf  
Broken  
Replace

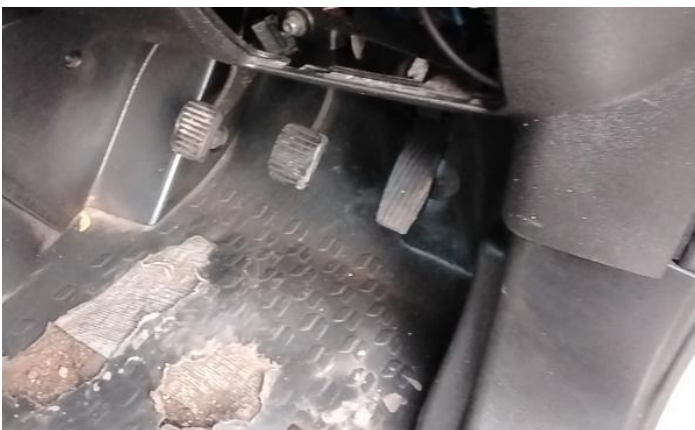
19: Fascia Panel  
Missing  
Replace

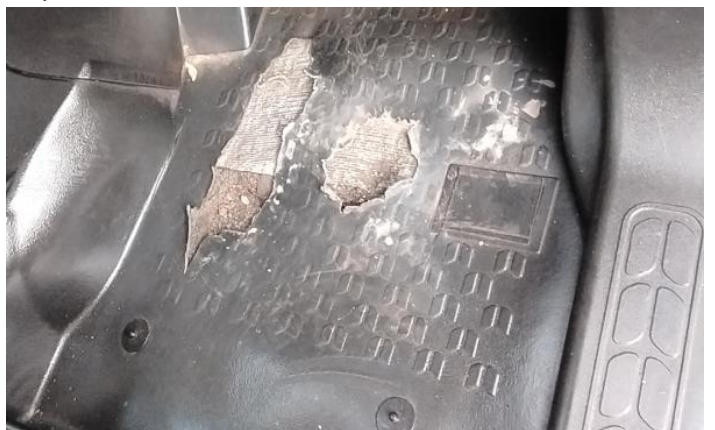
20: Carpets Front  
Holed  
Over 3mm

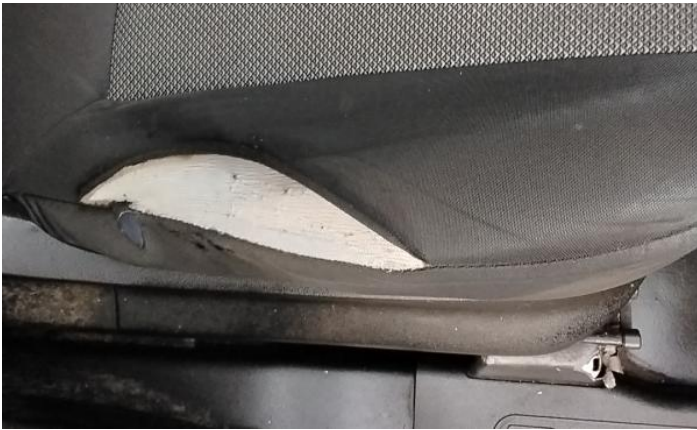
21: Seat Base Cover osf  
Torn  
Over 3mm

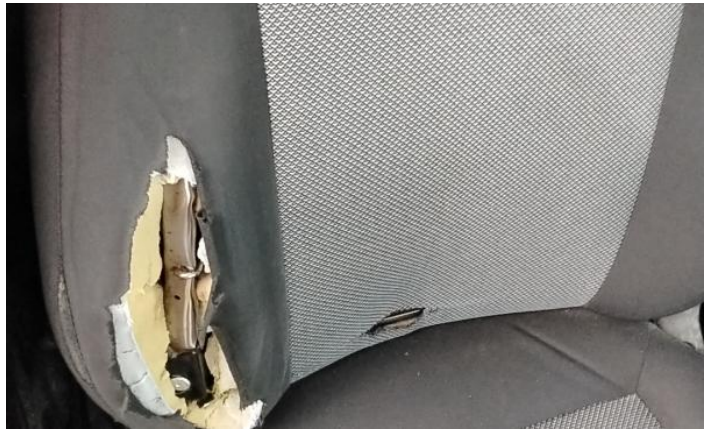
22: Seat Back Cover osf  
Holed  
Over 3mm

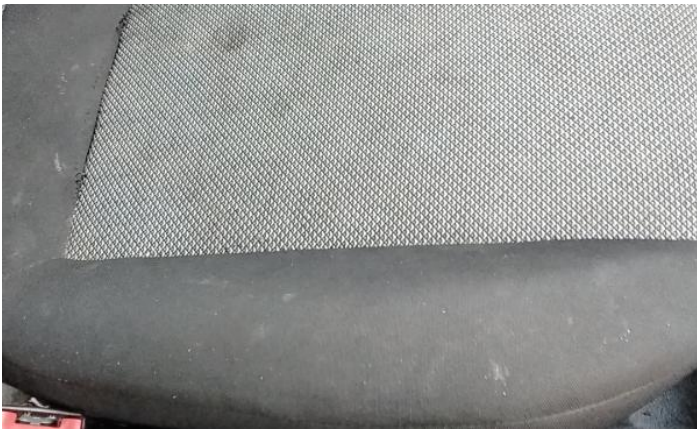
23: Seat Base Cover nsf  
Soiled  
Heavy

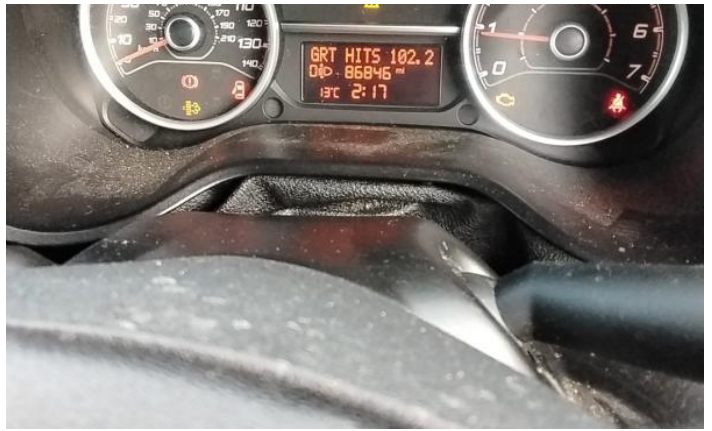
\*WARNING LIGHTS ON DASH\* AD-BLUE

24: Dash Warning Lights  
Displayed  
No Action
