# VEHICLE INSPECTION REPORT

**SA21ZZF**

## Fiat Doblo Work Up 1.6 Multijet II 16V

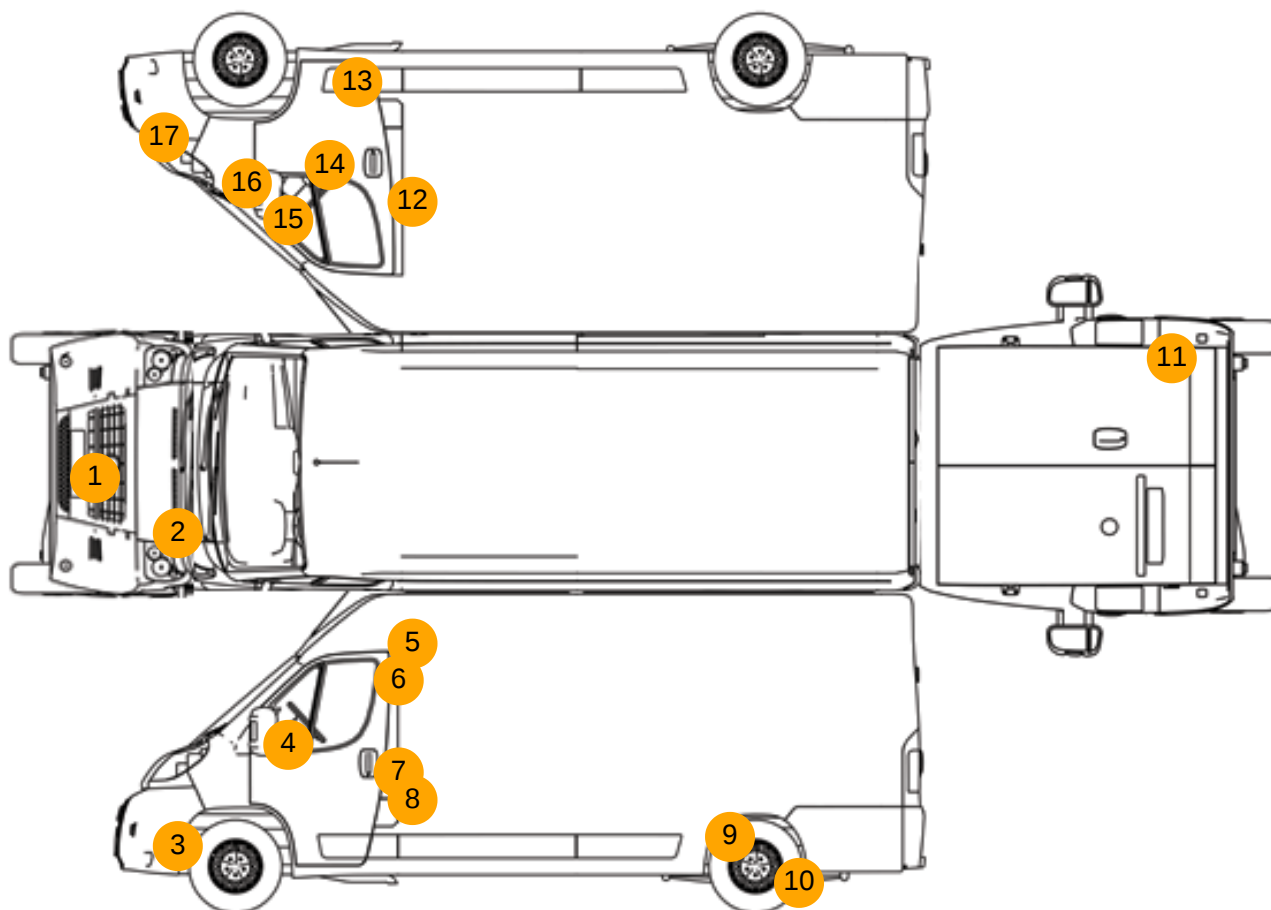
## Condition Check

1: Number Plate Front  
Broken  
Replace

2: Bonnet  
Dented  
With Paint Damage

4: Door Mirror Assy nsf  
Broken  
Replace

7: Door nsf  
Dented  
With Paint Damage

11: Lamp osr  
Broken  
Replace

15: Door Mirror Assy osf  
Broken  
Replace

16: Wing osf  
Dented  
With Paint Damage

18: Door Pad osf  
Broken  
Replace

19: Fascia Panel  
Missing  
Replace
